BELZONA EFFECTS EMERGENCY REPAIRS TO LEAKING SWIMMING POOL

Public swimming pool, British Columbia, Canada

August 2011

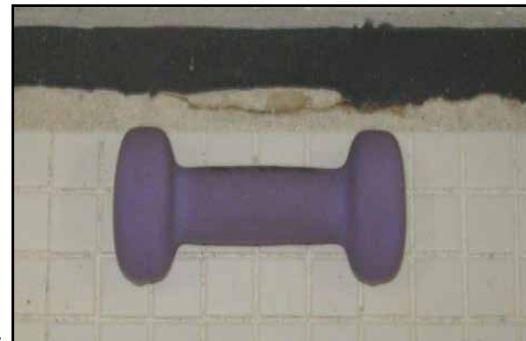
Vibration from the use of a “jackhammer” by a contractor in the pool basin to expose leaking pipes had caused cracks to develop in the concrete grout forming the edges of this pool’s unique expansion joint system. Dye testing located 12 separate leaks.

1. The grout used to form the expansion joint sides, and the crack in it, are visible above the hand weight used to mark leak locations during dye testing
2. The void beneath the crack is exposed
3. The joint repaired. Twelve separate leaks were isolated and sealed

Application was carried out in accordance with Belzona Know-How System Leaflets FPA-5 & FPA-6. Cracked grout was removed and joint edges rebuilt with Belzona® 4111, followed by repair with Belzona MP Elastomer of the expansion joints in affected areas.
