BELZONA RESTORES PROFILE OF BALL MILL

Cement plant, Bulgaria

Ball Mill for grinding limestone in cement production

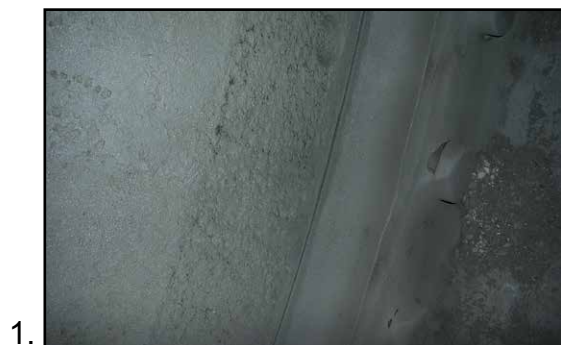
Severe wear particularly on the front wall and feed tube into the main shell.

1. View of severe abrasion damages were clearly evident after dismantling the tiles and blasting the surface
2. Application in progress
3. Completed application of the front wall
4. Additionally application of Belzona® 4111 system to restore the profile of the shell

Application was carried out in accordance with modified version of the Belzona Know-How System Leaflet SHM-7. Belzona® 4111 was applied around connecting bolts on the front wall and the shell. Belzona® 1812 was used to restore profiles lost through severe erosion. Belzona® 1121 was used for smoothing the areas with small pitting and erosion damages. These applications were carried out before re-fitting the wear resistant tile lining.
