BELZONA® PROTECTS A MASSIVE THICKENER AT A STEEL MILL

Thickener at a steel mill

Thickener suffering from a severe corrosion

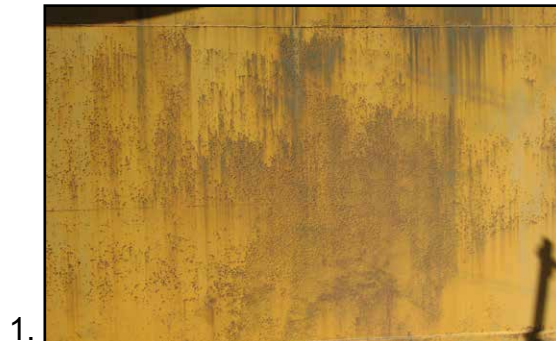
1. The walls of the thickener suffering from corrosion
2. Application of Belzona 5891 by spray
3. Belzona coating damaged caused by welding work done to the outside of the thickener. The damage was faired with Belzona 1111 and overcoated with Belzona 5891
4. The walls of the thickener after 1-year inspection

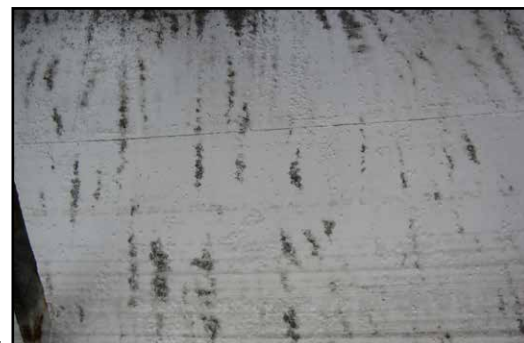
4.

The thickener has been in service for 5 years since the repair with Belzona was done. Both 1-year and 5-year inspections found the equipment in a good condition.
