BELZONA SEALS LEAKING WELD ON STORAGE TANK

Chemical & Additive manufacturer, Essex, UK

Chemical storage tank

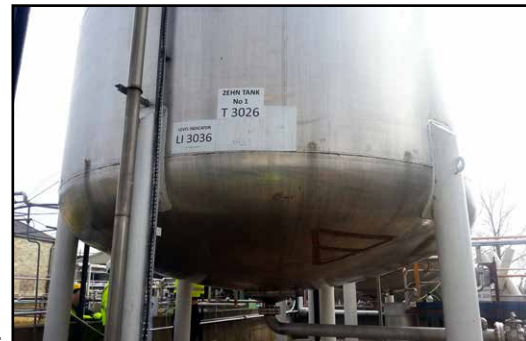
The aggressive nature of additives held within the tank had caused leaks to appear along the welded seam around the base. Due to the high cost and high demand of the additives a lengthy shutdown for repairs was not an option.

1. Leaking tank
2. First layer of Belzona® 9341 (Reinforcement Tape) being laid over the Belzona® 4301
3. Three coats of 4301 and two layers of 9341 were applied
4. Finished application being unmasked
