## BELZONA SOLVES THROUGH WALL CORROSION ON SLUDGE BUFFER TANK

Sewage treatment site, UK

Sludge buffer tank fabricated from glass coated mild steel.

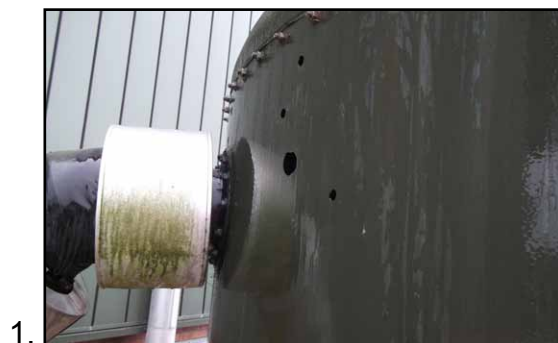
The sludge buffer tank was suffering from through wall corrosion at the vapour interface level. The tank could not be taken off line for an extended time which traditional repair methods would require due to demand. Any repairs would have to be carried out without hot works or the use mechanical equipment due to the risk of sparks.

1. Close up view of through wall defects
2. Plate bonding with Belzona 1161
3. Repairs coated with Belzona 5831
4. Completed application
