BELZONA HELPS KEEP THE PORT OPEN

Port authority, London, UK

Hull of a survey vessel operating on the river Thames.

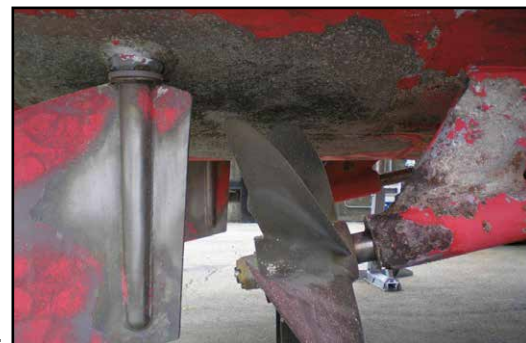
After 10 years of service on the river the hull of the vessel was suffering from cavitation around the propellor area. Previous repair method had been welding.

1. The vessel
2. The affected areas
3. Cleaned, blasted and Belzona® 1111 applied
4. Belzona 1341 applied

The application was carried out in accordance with Belzona Know-How System Leaflet SOS-1 & SOS-2, Belzona® 1111 was used to build up the worst affected areas and then Belzona® 1341 was then brush applied to provide overall protection.
