BELZONA GETS HOT AND HUMID

Food Production Plant, UK

Gas supply pipes.

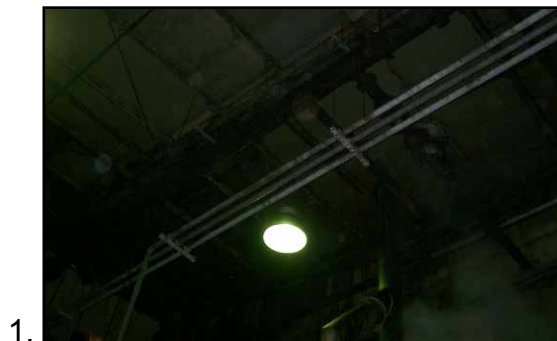
1. Location of gas pipes in ceiling
2. Corroded pipe with constant surface condensate
3. Finished section of pipe from Phase 1

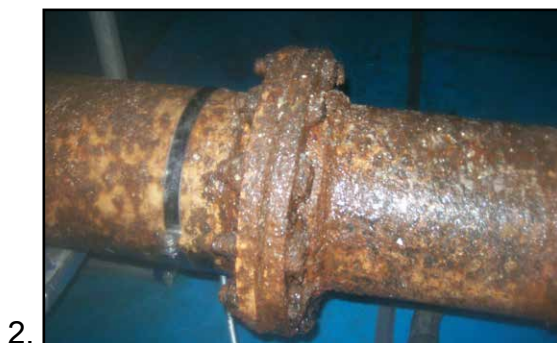
A well known crisp manufacturer had a series of aging gas pipes of diameters ranging between 4 to 8 inch. These heavily corroded pipes were located in the ceilings above production equipment and the packing conveyors. In addition, because of the processes in the rooms beneath, the roof area had excessive heat and humidity, with water condensate perpetually laying on the pipes. Grit blasting was not an option due to production beneath and so Belzona was approached to offer an anti-corrosion system that could be applied in such difficult circumstances.
