## BELZONA SEALS LEAKING MUSIC ROOM ROOF

Prestigious boarding school, Somerset, England

Roof over the music room at a prestigious private school

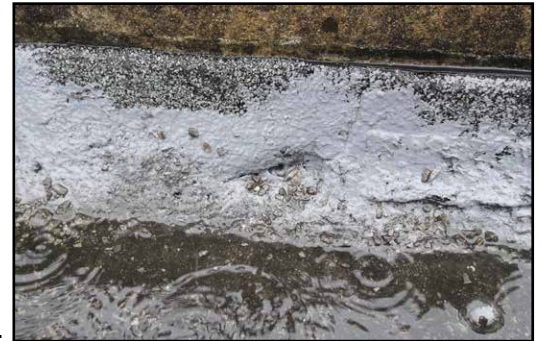
Breakdown of the old bituminous substrate had allowed multiple area's of water ingress causing damage to the fabric of the building & creating health and safety issues. Due to it's location adjoining a listed school building a hot applied system was not acceptable.

1. Close up of previous repairs which had failed
2. Preparation of the roof by removing loose chippings
3. First coat of Belzona 3131 being applied with reinforcement sheet
4. Completed application several months later
