BELZONA SEALS AND PROTECTS TRANSFORMER FINS

Cooling fins on a 33Kv transformer.

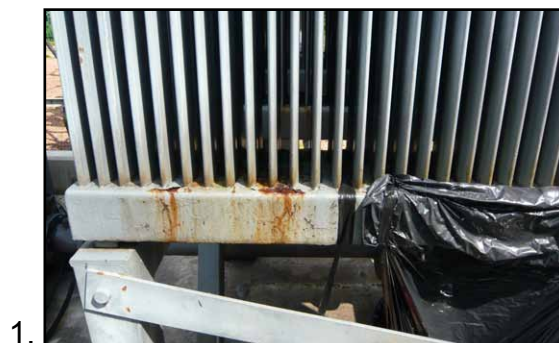
Over the years, corrosion had caused loss of wall thickness at the base of the transformer fins with leaks beginning to occur.

1. Fins before preparation
2. Plates being bonded to side and bottoms of the fins
3. Completed pour using Belzona 5831
4. Finished Application

The application was carried out in accordance with Belzona Know-How System Leaflet VPF-11a. The cooling fins were pressure cleaned and prepared where possible with an MBX Bristle Blaster. Live leaks were stemmed with Belzona 1291 and Belzona 1221. The fins were encapsulated using a 3mm metal plate bonded with Belzona 1161. Belzona 5831 was poured in to seal and encapsulate all the fins and then finally used to coat the fins.
