BELZONA SEALS CORRODED SEWAGE PIPE AT BUSY POLICE HEADQUARTERS

Police Headquarters, Bedfordshire UK

March 2013

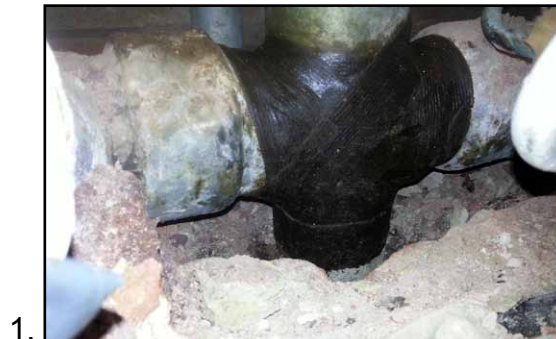
1. Corroded pipe wrapped with adhesive tape
2. Adhesive tape removed showing corroded hole and crack
3. Corroded area after cleaning and then abrading with MBX Bristle Blaster
4. Completed repair

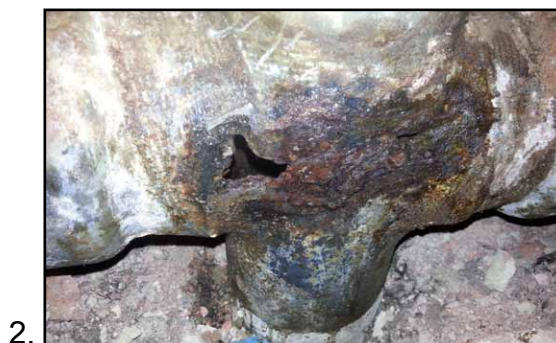
A 4" cast iron sewage pipe behind toilets on the 3rd floor started leaking at the point where 4 x pipes connect, causing water damage to the toilet blocks on both floor levels below.
