## BELZONA INSITU SHAFT REPAIR SOLUTION SAVES DAYS OF LOST PRODUCTION

Lime stone quarry, SW England

Main drive roller on conveyor loading finished product to trains.

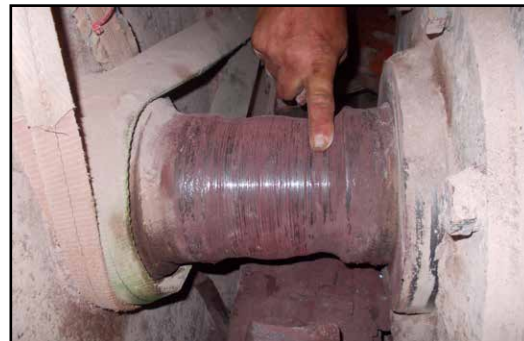
1.

Bearing Failure had caused severe damage to the shaft stopping the loading of trains and the ability to meet customer deadlines potentially costing the quarry hundreds of thousands of pounds in lost revenue. Traditional repair method of complete drum replacement would require the removal of the building's roof and some of the structural frame which houses the conveyor, hire of a crane & manufacture of a new roller and rubber lagging which could take over five days to complete, this was not acceptable to the quarry or their customers.

### PICTURES
