## BELZONA CREATES POSITIVE GRIP ON RUBBER CLAD CONVEYOR DRIVE DRUM

Gravel pit, Croatia

July, 2013.

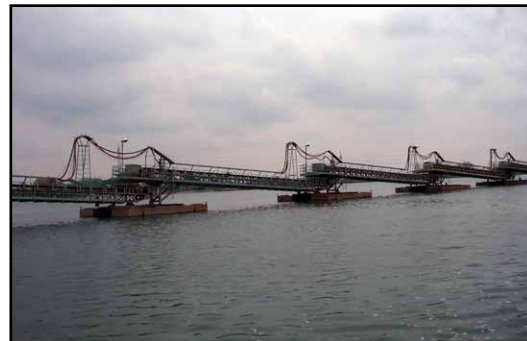
Rubber clad conveyor drive roller (diameter 400 mm and length 800 mm) positioned on a conveyor system for transportation of gravel and sand from the dredger ashore. The gravel pit was operating 24/7.

1. Transportation system for gravel and sand from the dredger ashore
2. The roller with worn rubber cladding
3. Measuring for chevron-styled stripes
4. Application finished

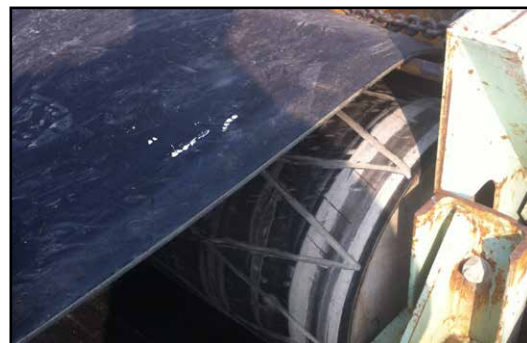
2.

The worn rubber cladding was allowing belt slippage. Customer needed to solve the problem without dismantling the equipment in order to minimize downtime.
