## BELZONA SEALS LEAKING BALCONY ROOF AT WORLD FAMOUS COLLEGE

College, Cambridge, UK

August 2013

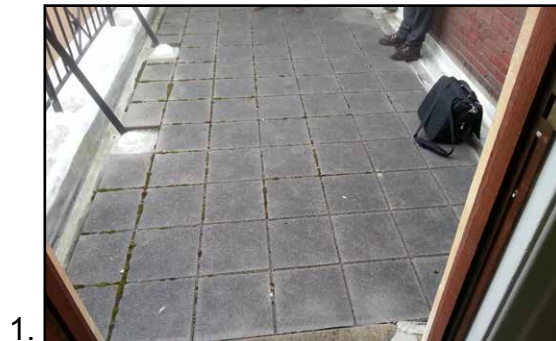
The asphalt roof was leaking underneath the concrete slabs, causing water damage to the rooms below. To repair the roof the College was planning to remove the concrete slabs, replace the asphalt roof and then reinstall the concrete slabs.

1. Leaking balcony roof with paving slabs
2. Close up of paving slab edge
3. Gaps between slabs filled with Belzona® 4131
4. Balcony roof coated with Belzona® 3131 system with 3rd coat incorporating Belzona® 9231 aggregate anti-slip system

Application was carried out in accordance with Belzona Know-How System Leaflet RPA-6. The gaps between all paving slabs were cleaned and filled with Belzona 4131. A fully reinforced Belzona® 3131 system was then applied to weatherproof the area. This was followed by a further coat of Belzona® 3131 blinded with Belzona 9231 aggregate to create a non-slip walkway.
