## BALCONIES WATERPROOFED WITH BELZONA

Boutique Hotel, London

Balconies on Victorian era hotel

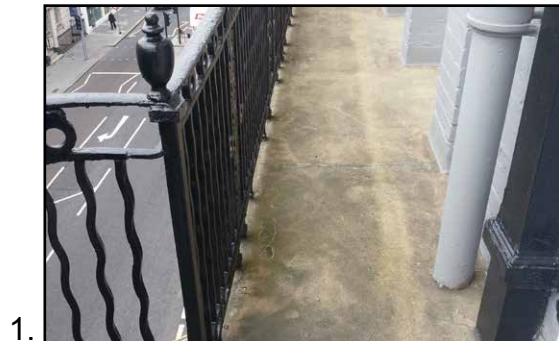
The aging balconies had numerous fine cracks and the hotel had been suffering from water penetration issues. With high occupancy rates a quick turnaround was essential.

1. Unprotected balconies
2. Contractor carrying out application
3. & 4. Completed work

Application was carried out in accordance with a modified version of Belzona Know-How System Leaflet TCC-15. The Belzona 5811 was applied using brushes and squeegees.
