EFFLUENT CLARIFIER TANK REFURBISHED WITH BELZONA

Paper Mill, SW England

Concrete effluent tank

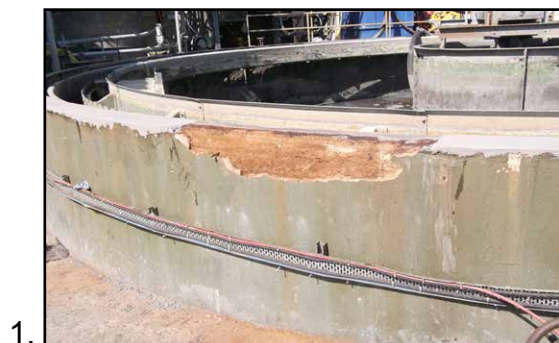
Breakdown of the concrete substrate due to water ingress and freeze thaw cycles had left the tank at risk of stoppages to production which the client could not afford. Traditional repairs or replacement would take too long and did not fit into the client's production schedule. The client only had a five day window which they could have the clarifier off line,

1. Area of damage to concrete substrate
2. Application of Belzona® 4131
3. Close up of completed application
4. Completed application, *note customer painted the tanks outside after coating with Belzona® 5151 to match corporate colour scheme.
