## BELZONA PROVIDES NEW LIFE FOR A BRICK FACTORY BELT

Brick factory, Kent, England.

September 2013

Primary conveyor delivering clay into the building from the quarry.

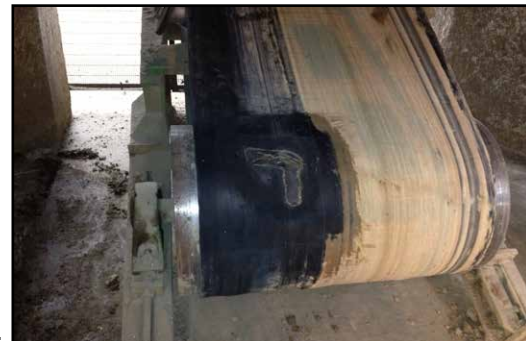
1.

After years of use the belt had developed a tear and clay was penetrating the layers in the belt, if the belt was to deteriorate further the factory would need to employ an unplanned shutdown.
