BELZONA GIVES OLD PROPERTY NEW LEASE OF LIFE

Farm house, Worcestershire, UK

Old farm house walls.

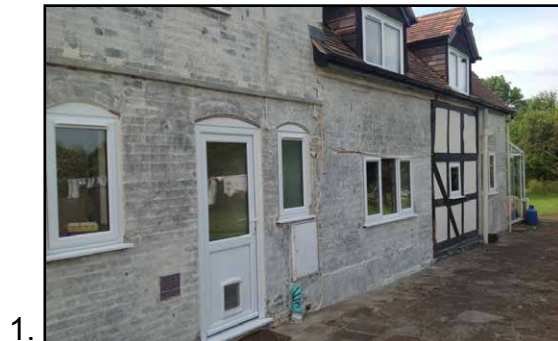
Failure of the existing paint was allowing damp to penetrate into the walls leading to further deterioration. Client needed system to protect walls and approve appearance.

1. Surface Preparation
2. Application of Belzona® 3911 (PSC Conditioner)
3. Completed Belzona® 5151 Application.

Application was carried out in accordance with Belzona Know-How System Leaflet WPA-1. A mechanical wire brush was used over the entire surface to remove loose material. After treating with fungicidal wash the Belzona® 5151 system was applied.
