## BELZONA REPAIRS AND PROTECTS CENTRIFUGAL PUMP HOUSING IN AN INDUSTRIAL MINE

Gold Extraction Mine, Guatemala

Reconstruction and abrasion-resistant lining of the pump housing of the mud conveyor.

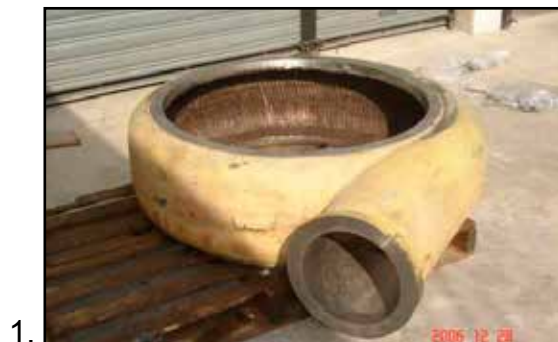
1. Centrifugal pump housing
2. Holes due to severe abrasion
3. Application of the lining
4. Application completed

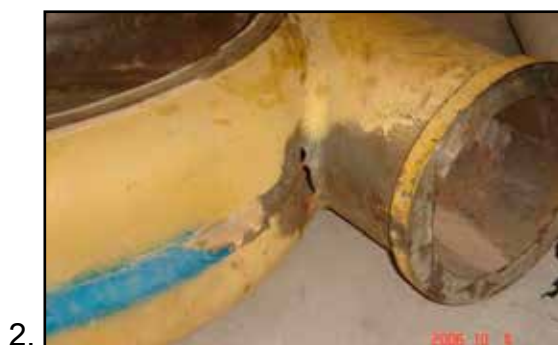
Due to the severe abrasive conditions caused by the suspended solids, the pump casing was severely stripped and holes appeared in the housing.
