BELZONA REBUILDS DIVERTER VALVES FOR CEMENT PLANT

Worn diverter valve

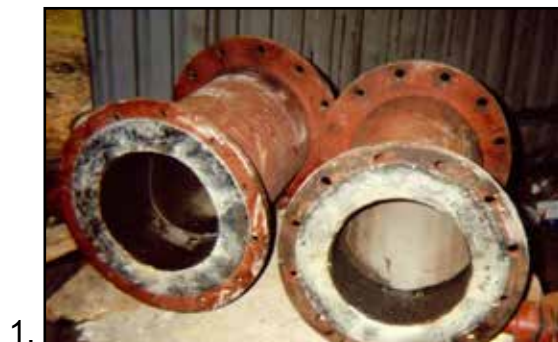
1. Two valves in workshop waiting to be rebuilt
2. Worn areas where valve flap sits against the valve body are marked out with chalk and rebuilt
3. Rebuilt valve. Area ahead and behind valve flap were rebuilt

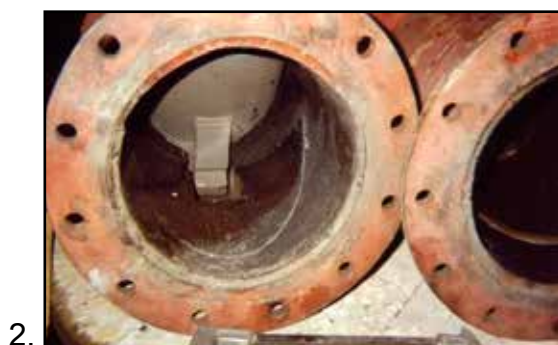
The seating area of the diverter valve would wear.

The use of Belzona 1811 allows the maintenance department to rebuild the diverter valves on a regular basis on site and often in place saving both downtime and replacement costs
