BELZONA PROTECTS ROTARY REACTOR (LEACHING TANK)

Mining Company, Indonesia

November, 2006

Rotary Reactor (Leaching Tank)

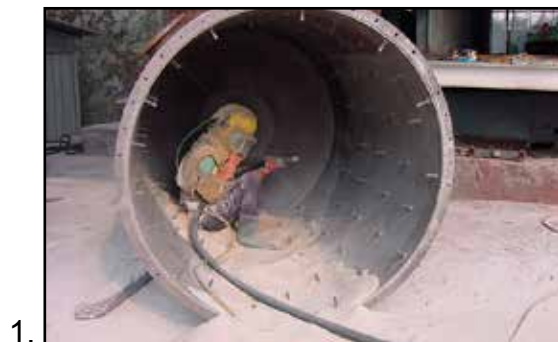
1. Internal wall, prior to surface preparation
2. Degreasing with Belzona 9111
3. Application of Belzona 1392
4. Complete application
