BELZONA REPAIRS SCORED HYDRAULIC RAM

Damaged hydraulic ram

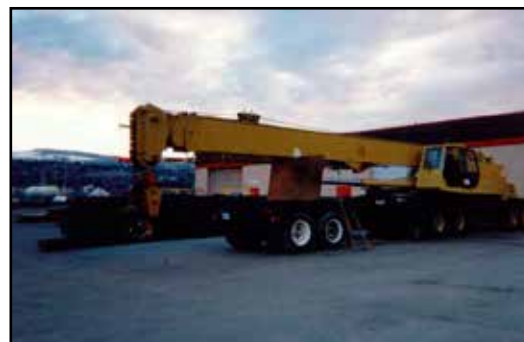
Hydraulic rams had been subjected to sever mechanical damage around the seal area, rendering them ineffective. This was the only heavy duty lifter used for loading on site. New ram was not immediately available.

1. View of damaged ram
2. Damaged areas "V" out
3. Rebuilt with Belzona 1221
4. Completed repair.
