BELZONA REBUILDS MAIN PIVOT SHAFT ON SITE

Worn pivot shaft

Original bearing had badly worn the main pivot shaft of this excavating crane.

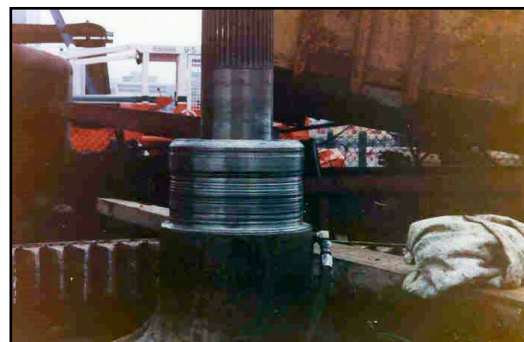
1. View of preparation in progress
2. Application in progress
3. Completed application with mold still in place. Mold removed after material had set up leaving a remolded bearing surface
