BELZONA REPAIRS RUBBER LINED SLURRY PUMP

Rubber lining on a slurry pump

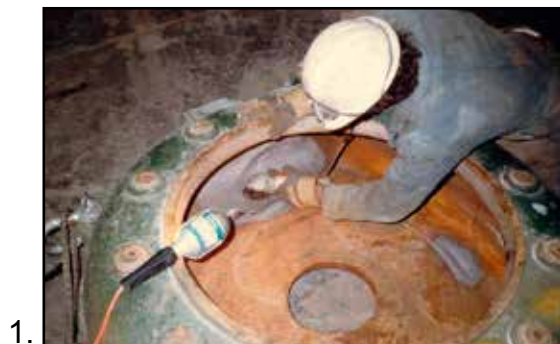
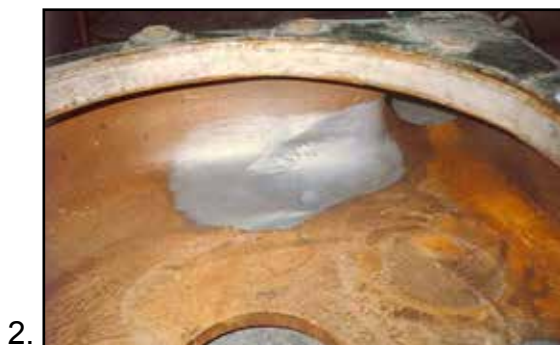
A hole had worn into the rubber lining in a number of areas from the coal slurry and had started to erode the metal casing.

1. Preparation of the damaged areas in progress
2. Preparation completed
3. Rubber liner rebuilt

Belzona 2111 (D&A Hi-Build Elastomer)

Application carried out in accordance with Belzona Know-How System Leaflet SHM-11
