BELZONA REBUILDS WORN CAT D9 SPLINE SHAFT ASSEMBLY

Worn spline shaft

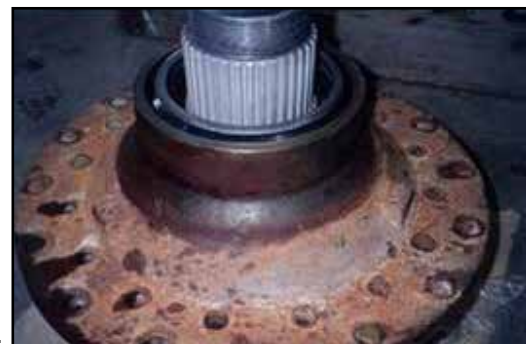
The main drive spline on D-9 cat had worn loose over many years of service.

1. View of worn spline shaft assembly
2. Belzona 1111 Super Metal applied to worn splines
3. Components reassembled
4. The main framework that the Spline assembly is being bolted to
