BELZONA EXTENDS THE LIFE OF DAMAGED TIRE

Repair of the side wall of a tire

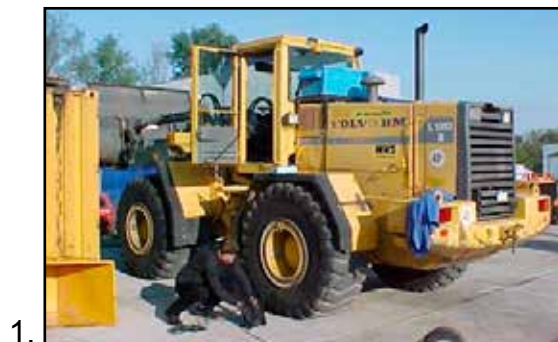
The side wall of a tire, close to the rim, had been cut by a stray piece of metal

1. Vehicle with damaged tire
2. Initial preparation underway with the removal of any loose material
3. The surface around the damaged area is prepared with a special roughing tool
4. Completed application.
