BELZONA ELASTOMERS USED TO PROTECT CONVEYOR BELT CLIPS

Belt clip

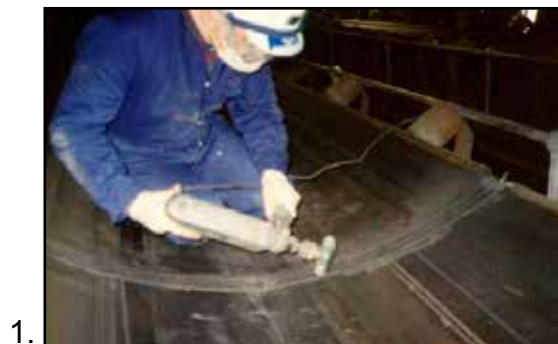
1. Preparation of the clip joint and damaged area in progress
2. Preparation completed
3. Area masked off and the prepared area conditioned with Belzona 2911 (QD Conditioner)
4. Completed application.
