BELZONA 1000 SERIES PRODUCTS RE-SEAT WEAR PLATES

APPLICATION SITUATION
Worn Bradley Pulverizer

PROBLEM
The base plate of the Bradley Pulverizer had worn unevenly making it difficult to effectively reinstall new wear plates

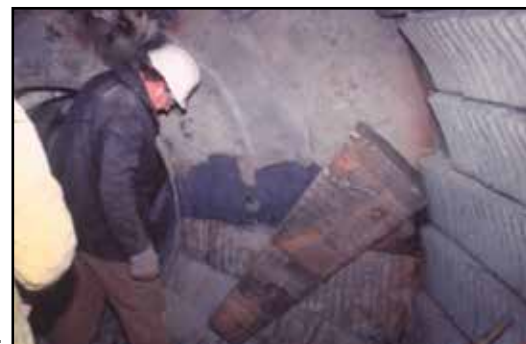
1. Belzona 1121 has been applied to all the worn areas, while a release agent has been applied to the underside of the new wear plates to ensure that they are easily removed when required
2. Installation in progress
3. Completed application.
