BELZONA PROTECTS CONTAINMENT AREA AT A TREATMENT PLANT

Concrete pads, spalling floor areas

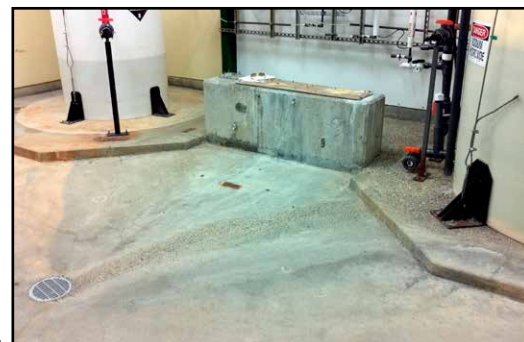
Spalled floor areas needed repair and coating to prevent further damage and provide secure containment for potential spillage. Treatment chemicals stored on concrete pads without protective coating including surrounding floor area and drain. Spalling to floor areas was evident where spillage occurred.

1. Wastewater plant chemical storage area before repairs & coating
2. Storage drain area spalling
3. Storage area after repairs & coating

The application was carried out in accordance with Belzona Know-How System Leaflets FPA-1, FPA-3. Belzona 4111 was hand troweled over most severely spalled areas prior to hand application of two coats of Belzona 5811.
