BELZONA STOPS WATER LEAKING INTO AIRCRAFT HANGAR

Damaged outer wall flashing of an airplane hangar.

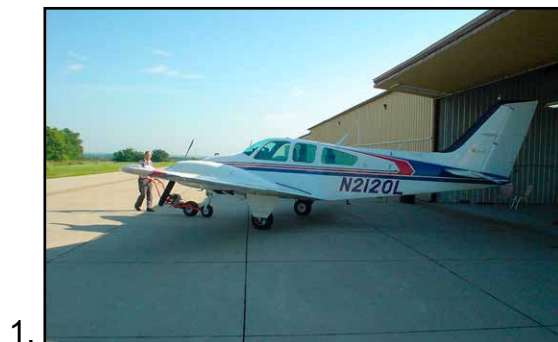
1. Picture of airplane hangar
2. Damaged flashing and area of penetration
3. Berm built to direct water away from the door
4. Picture of completed repair

The flashing was re-secured to the asphalt with mechanical fasteners. Two coats of Belzona 3121 was then applied a few inches above the flashing and down onto the asphalt. Also, a small berm was fabricated with Belzona 4111 to divert run-off water away from the door.

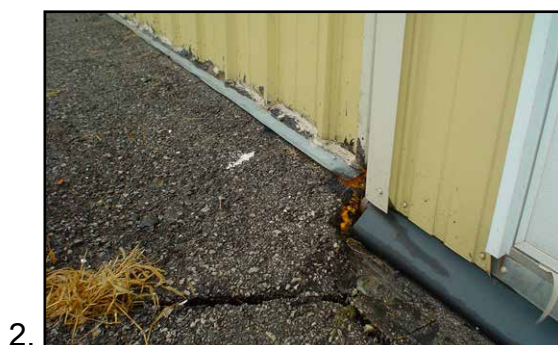
This hangar at a municipal airport was leaking water into aircraft hangars due to the damaged flashing and creating a slip hazard near the entry door. Mastics and caulk had failed and a more permanent solution was needed.
