BELZONA RESCUES CELL PHONE ANTENNAS

Deer Park, WA, USA

June 2014

Steel mounting plates.

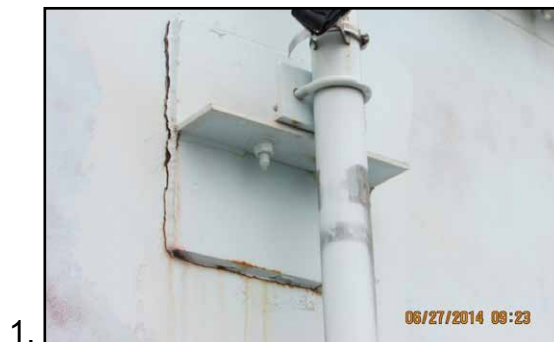
A series of steel plates with expensive cell phone antennas mounted to them on this water tower were found to be failing. The previous product had dis-bonded and they were no longer attached to the water tower.

1. Failing plate in place
2. Failed plate
3. Application complete
4. View from the ground

Previous material was removed, the surface of the plates were ground clean, and then roughened as well as the sides. The four sides of the plate were also chamfered to produce an additional mechanical bond once the Belzona 1111 had cured. The steel surface of the water tower was also ground to remove the previous material and then prepared with the MBX Bristle Blaster. Belzona 1111 was then mixed, and applied and the plate was remounted in it's original position.
