## BELZONA REPAIRS AND PROTECTS LEAKING FLANGE ON CHILLER

Chiller had a leaking flange.

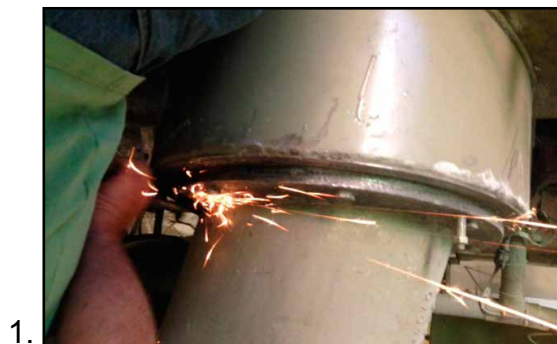
1. Surface preparation to roughen the substrate
2. Conditioning the substrate
3. Applying reinforcing cloth over Belzona 2121
4. Completed application

The surface was prepared with a grinder to roughen the substrate. Then, the application area was taped off. Belzona 2911 was applied to condition the substrate and allowed to dry. We then used Belzona 2121 in red and stippled in reinforcing cloth over the seam and bolts. We went over and applied a second coat of Belzona 2121 in black. We let it sit overnight and it stopped the leak.
