BELZONA STOPS LUBE LEAKS

Concrete wall leaking lube oil

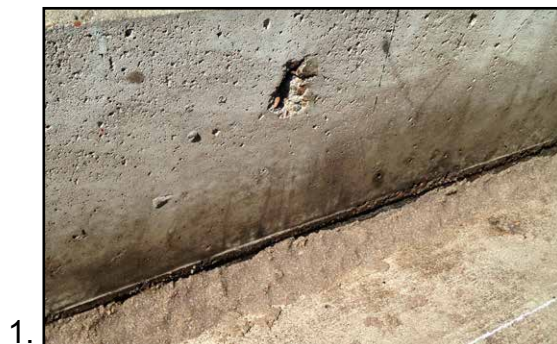
The customer stored lube oil within a small containment area, when leaks would develop they would by-pass and go under the wall onto the ground outside of the containment area.

1. Before repair
2. During repair
3. Application completed
