CONDENSER TUBE SHEET RESTORED WITH BELZONA

Main Condenser tube sheet at a nuclear power station

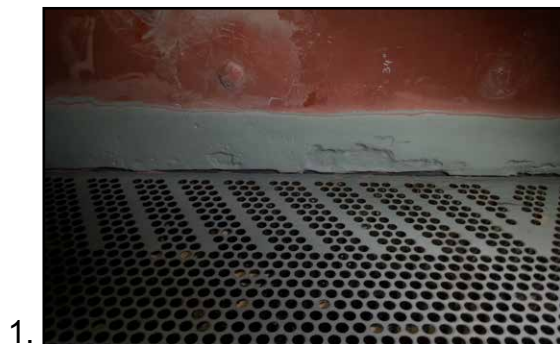
1. Tube sheet and waterbox edges following thorough grit blasting
2. Close up picture of the severe pitting along the water box edge
3. Following application, the Belzona 1331 was dressed down around each tube
4. Finished application. Also visible at the top of the image is the Belzona 2211 joint

Application was carried out in accordance with Belzona System Leaflets HEX-1 & HEX-5. After grit blasting, the eroded areas were rebuilt using Belzona 1311. Once the substrate profile was restored, Belzona 1331 was applied as a two coat system to provide overall corrosion protection across the affected areas on the tube sheet and water box. Finally, a flexible joint was created between the waterbox and the tube sheet using the Belzona 2211 to allow for movement between these parts.

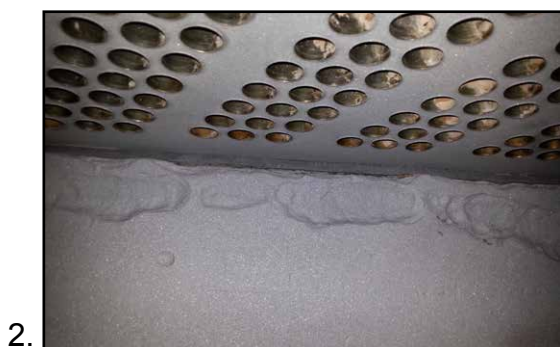
The tube sheet had suffered from bimetallic corrosion around the tubes and at the edges of the tube sheet as well as metal loss due to erosion.
