## BELZONA FIXES BAD WELDS ON A TRANSFORMER

Leaking corner weld on an active transformer.

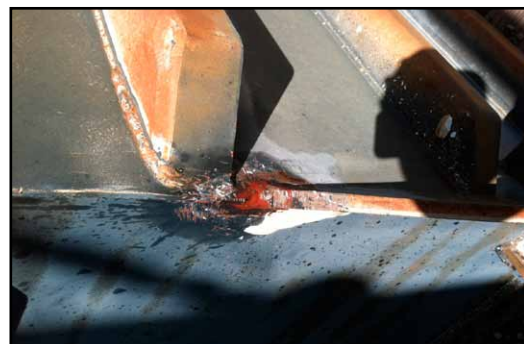
Corner bracket on an active electrical transformer was leaking oil.

1. View of the leaking weld
2. Side view of the leaking weld, including the oil stain surrounding the weld
3. Application completed

The surface was prepared using a coarse grit grinding wheel. The Belzona 1161 was applied according to the Instructions For Use. Application was carried out in accordance with a modified version of Belzona Know-How System Leaflet TCC-1.
