## BELZONA SAVES TUG BOAT COMPANY \$200,000+

**APPLICATION SITUATION**  
Tug boat in dry dock for routine repairs.

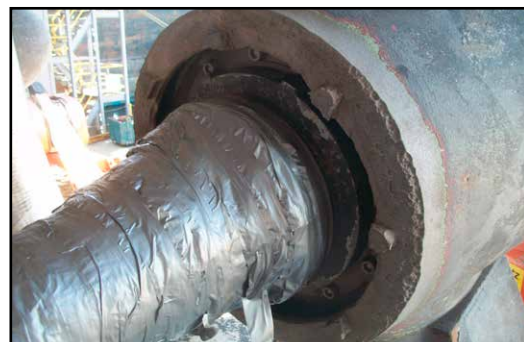
**PROBLEM**  
While in dry dock, it was found that the lower half of the port and starboard Kort nozzle drive assemblies had severe erosion on the propeller side of the housing.

1. Eroded housing
2. Belzona 1311 applied and the former installed
3. Repair completed
4. The Port and Starboard Kort nozzles and drive assemblies shown while the tug is in dry dock
