BELZONA BRINGS EXCAVATOR BACK TO SERVICE IN 1 DAY

Excavator shovel at salt mine

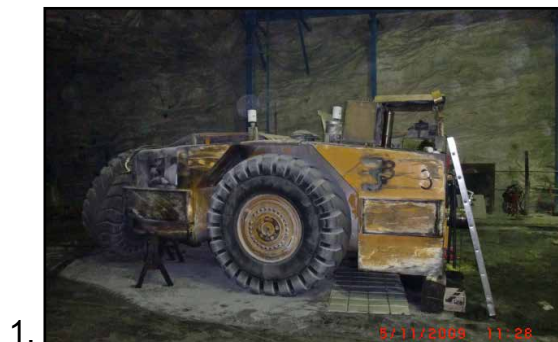
The severe conditions of corrosion and abrasion in the mine caused loss of metal in the articulated coupling, which resulted in reduced service life of the component.

1. Excavator shovel before the application
2. Injection of Belzona 1821
3. Final application
4. Bearing back to service
