## BELZONA REPAIRS TORN RIB BOAT SPONSON

**CUSTOMER**  
VA, USA

**APPLICATION DATE**  
2011

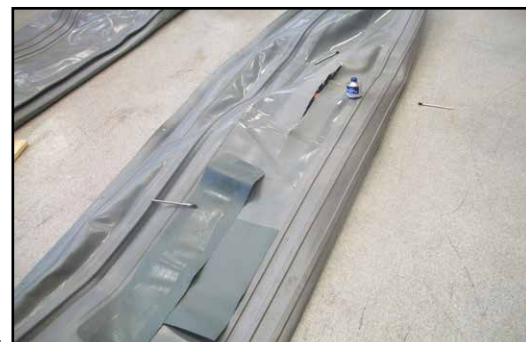
The sponson has an 18 inch long tear.

1. 18 inch long tear in the inflatable sponson of a Navy RIB boat
2. The repair area of the sponson and repair patches have been thoroughly roughened.
3. The inside patch bonded in place.
4. The outside patch bonded in place and the section of the sponson is shown inflated and holding air.
