BELZONA KEEPS A TRANSFORMER IN SERVICE

Electrical transformer.

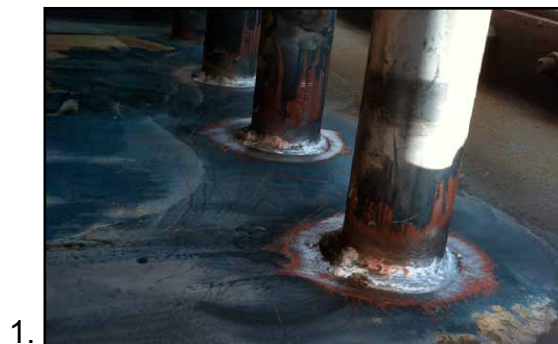
Welds on the circulation pipes of an electrical transformer were leaking oil, causing an environmental hazard, as well as a mechanical problem, and loss of oil which is essential to proper operation of transformers.

1. Leaking welds on the circulation pipes
2. Application completed

The application was carried out in accordance with a modified version of Belzona System Leaflet FBC-6. A grinder was used to prepare the surface, then Belzona 1161 was used to seal the seeping leak.
