BELZONA REPAIRS STEEL PIPE ELBOW AT A POWER PLANT

Pipe elbow

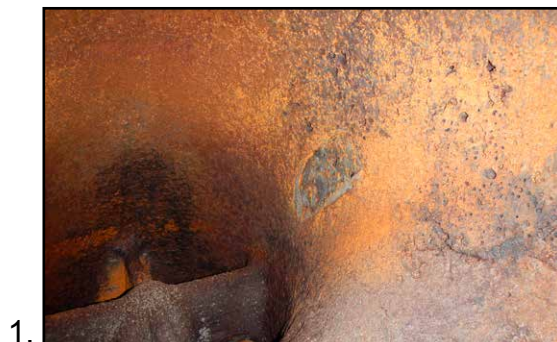
Very old pipe elbow needed to be replaced due to high corrosive pitting. It was close to having holes through to the concrete foundation of the historic building (power house).

1. Pipe elbow before the application
2. Pipe elbow after Sponge-Jet Blasting
3. Pipe elbow after application of Belzona 1311
4. Pipe elbow after application of Belzona 1321
