BELZONA 3411 SOLVES CORROSION ISSUE FOR A CHEMICAL PLANT

Chemical Plant, South Louisiana, USA

52" flange on vessel

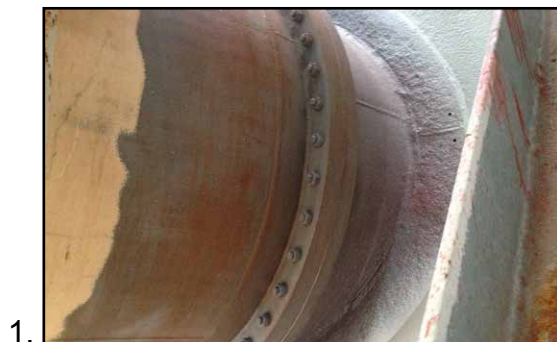
1. 52" Flange prepared for application, grit blasted
2. First coat of Belzona 3411
3. Second coat of Belzona 3411
4. Final sideview of flange
