SUCCESSFUL RESTORATION OF ROOF IN CENTRAL LONDON WITH BELZONA

Inverted roof covered in a single-ply membrane.

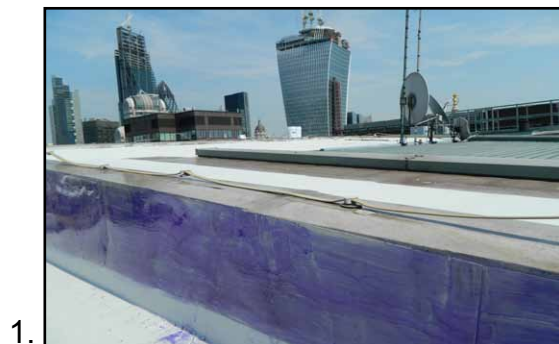
1. Surface being conditioned to ensure good adhesion
2. First coat of Belzona 3111 applied
3. Completed application
4. Completed application

The application was carried out in accordance with Belzona Know-How System Leaflet RPA-1. The upper level roof was cleaned and prepared before application of a fully reinforced Belzona 3111 system.
