## BELZONA REPAIRS AND PROTECTS ROTOR FROM EROSION-CORROSION

Vacuum pump rotor.

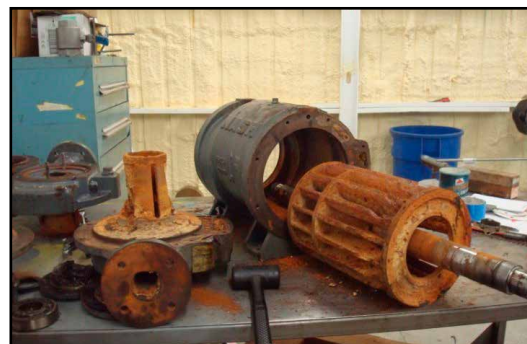
1.

During the overhaul of this plant's Nash Vacuum Pump it was determined that the components were showing extreme signs of erosion and corrosion and could benefit from a Belzona renovation.

### PICTURES
