## BELZONA REPAIRS PURGE TANK

South Florida, USA

May 2014

Purge tank with hot water.

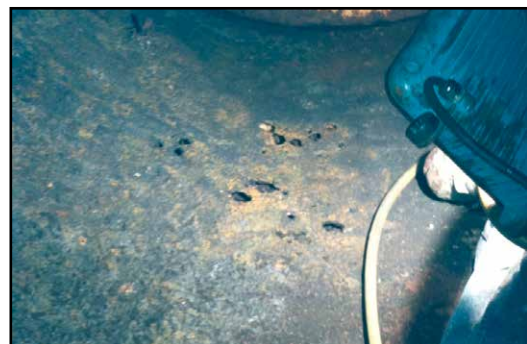
A purge tank was getting corroded to the point that hot water was seeping through small holes in the tank. Leakage and safety were a great concern.

1. Condition of the tank
2. Tank after grit-blasting
3. Bonding metal patches using Belzona 1511
4. View of the tank after two coats of Belzona 5892
