BELZONA'S REPAIR ALLOWS FOR A QUICK RETURN TO OPERATION

Baler loader at a busy recycling paper mill..

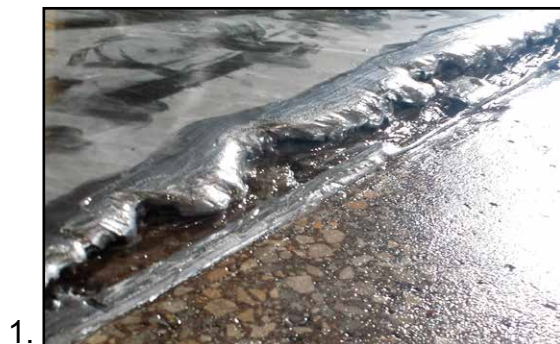
The concrete floor had begun to wear away due to abrasion from forklifts sliding bales into the conveyor. The steel was also excessively worn, causing a 2" lip for the bales to overcome.

1. Wear at loading point
2. Surface preparation with diamond grinding
3. Completed application
