BELZONA REPAIRS AIR HANDLING EQUIPMENT

Bearing seized for air handling equipment.

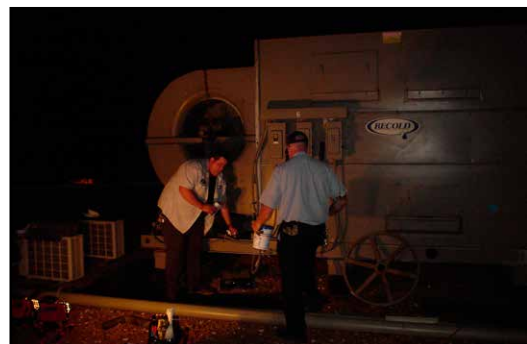
One of the bearings on this office building's air handler system failed and severely gouged into the fan's shaft. The cooling system was nearly crippled with a triple digit, Midwest July heat.

1. Air handler fan threw a bearing in the early a.m.; building without conditioned air for over 12 hours.
2. Customer secured the shaft for early a.m. repair.
3. Belzona repair completed before 6:00 a.m.
4. Completed application of shaft and ready to return to service that morning.

The shaft was supported and the pillow block was removed, exposing the damaged area. A suitable former was treated with Belzona 9411 and the bearing surface was roughened and degreased. Belzona 1111 was mixed and applied, then the form was clamped in place. After a short cure, a new bearing was installed and the air handler was placed back on-line. The application was carried out in accordance with Belzona Know-How System Leaflet MPT-2.
