BELZONA COATS CAPSTANS AND SAVES CUSTOMER THOUSANDS OF DOLLARS

Marine, South Louisiana, USA

Pitted and deformed capstans

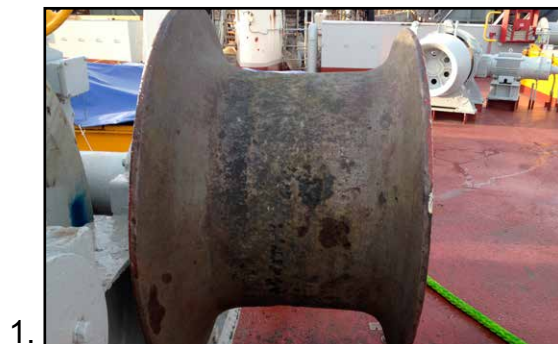
1. Capstan after hydro-blasting
2. Belzona 1311 being applied by Technician
3. Belzona 1341 final coating
4. Finished product on both capstans
