BELZONA REPAIRS DAMAGED SHAFT

Hotel, Missouri, USA

Air handler bearing failed, gouging shaft.

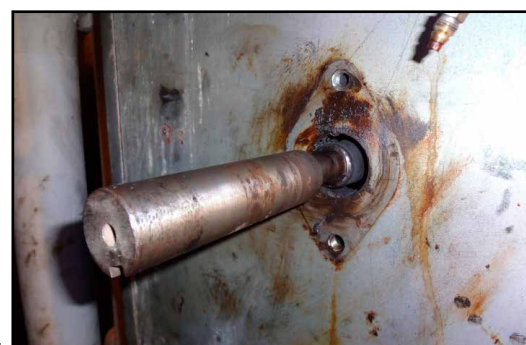
Bearing failure on the air handler for the main lobby of this busy downtown hotel wore into the shaft so severely that the cooling system was out of commission as the Spring weather was heating up.

1. Hotel storefront
2. Damaged shaft
3. Consultant assisting staff engineer with Belzona 1111
4. Completed application

A trained machine shop fabricated a split former to the exact dimensions and the shaft was quickly repaired in-situ with Belzona 1111. The application was carried out in accordance with Belzona Know-How System Leaflet MPT-2.
