## BELZONA REPAIRS BUTTERFLY VALVE GASKET

**CUSTOMER**  
MO, USA

**APPLICATION DATE**  
September 2006

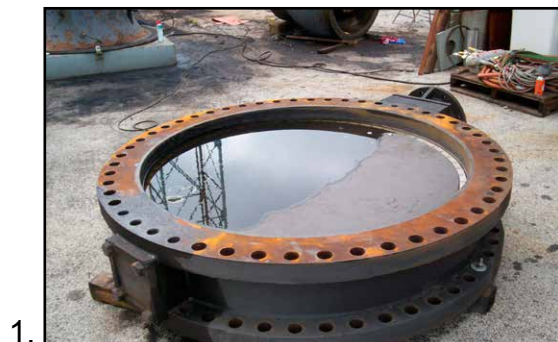
1. Blasted butterfly valve gasket
2. Application of product
3. Finished repair
4. Close-up of gasket prior to installation

The application was carried out in accordance with Belzona Know-How System Leaflet GSS-1 using Belzona 2131. After grit blasting the surface, heavy gauge wire was used to form a channel to apply Belzona 2131 to the proper thickness.
