BELZONA REPAIRS A RUBBER IMPELLER AT A SUGAR MILL

Sugar mill pump impeller

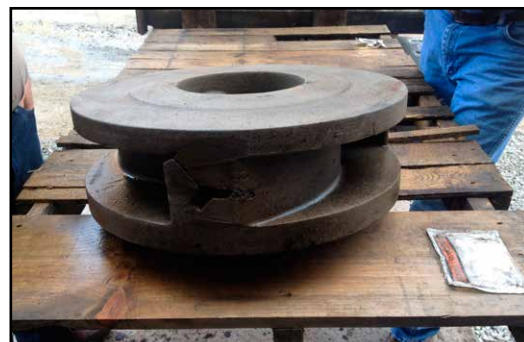
After years of use, impeller had cuts and holes that had to be repaired or impeller be replaced. The mill did not want to buy a new one if the impeller could be repaired.

1. Impeller before repairs
2. Worst area after degreasing; ready to be roughened up
3. Worst area after Belzona application
4. Finished repaired impeller ready for another grind season.
