## BELZONA REPAIRS SLURRY PUMP

Power Plant, Kansas, USA

Scheduled maintenance outage at power plant for an in-service ash slurry pump.

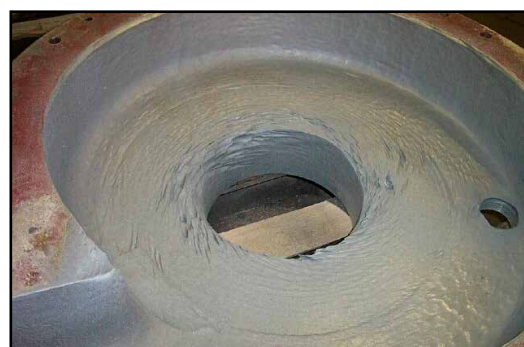
One of the plant's ash slurry pumps showed signs of severe erosion. Due to the extreme pitting and metal loss caused by entrainment, the plant would have resigned to discarding this pump and replacing it with a new one.

1. Plant site overview
2. Damaged pump prior to blasting
3. Blasted surface of pump
4. Completed application

Belzona offered a perfect alternative to replacing this stainless steel classifier pump. The application was carried out in accordance with Belzona Know-How System Leaflet SHM-11 using Belzona 1812.
